**Washington State Ferry Terminal
Structural Inspection**

Kingston Ferry Terminal

Br. No. 104/14FTP SID 0013936A Br. Name KINGSTON PEDESTRIAN RAMP

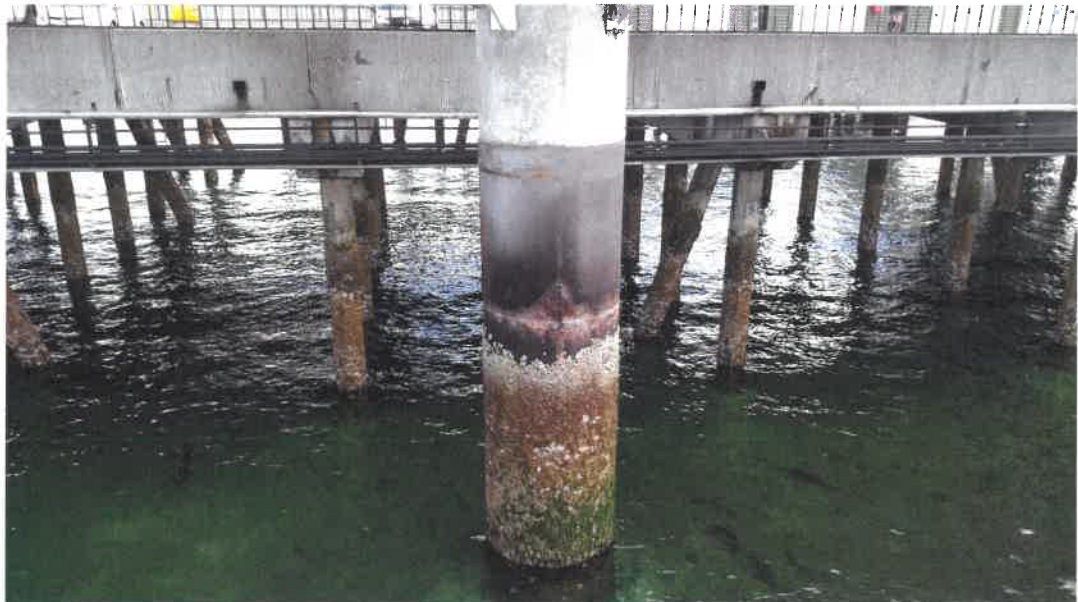
SI-48

Pier 3 column has coating failure with moderate rust above intertidal zone (Photo #48).

Pier 3 column has coating failure with moderate rust above intertidal zone.

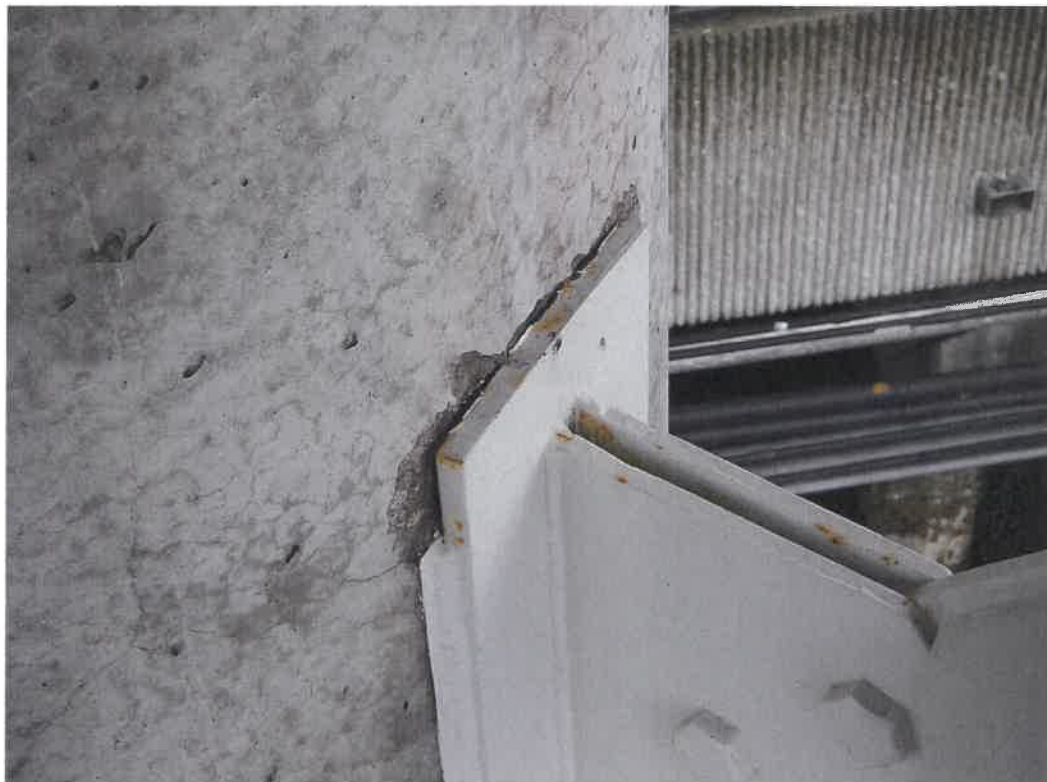
Pier 4 knee brace is field welded to the cast-in-place base plate (Photo #41). The chipped out spalls at the top appear to be an as-built condition.

Pier 4 knee brace is field welded to the cast-in-place base plate. The chipped out spalls at the top appear to be an asbuilt condition.

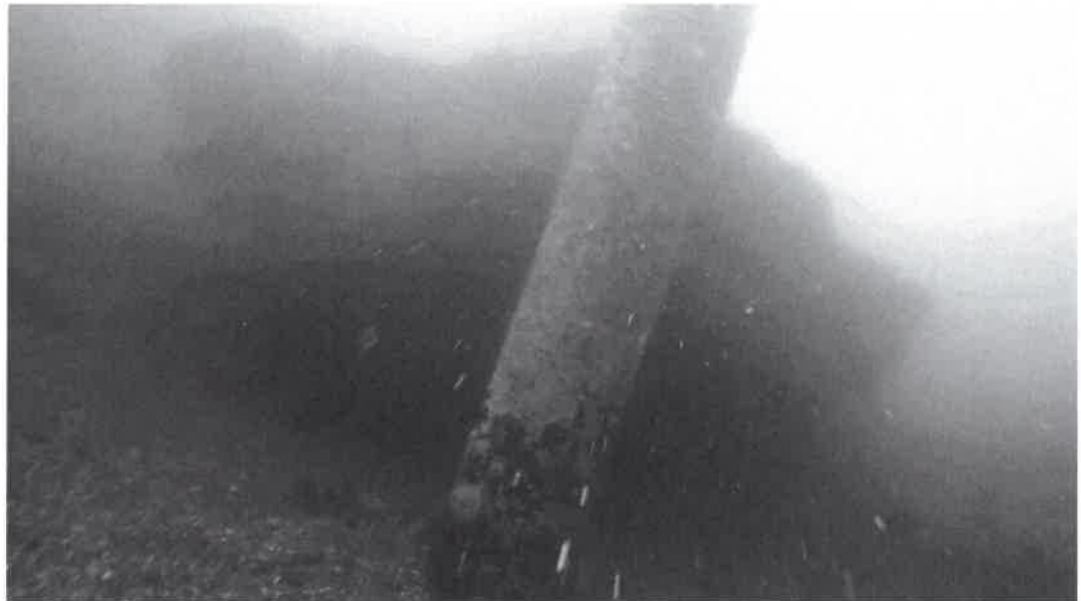
UW-3

The mudline around Pier 6, the supercolumn pier, has degraded up to 11-ft since original construction in 1993. Fifty feet of shaft embedment remains. The ground material surrounding Pier 6 includes erodible clay. Recommend WSF take periodic soundings around Pier 6 to monitor for further degradation.

Pier 6 supercolumn has a large concrete overpour which is up to 11-ft high. The pile in front is the Aux. Slip 1 right wingwall batter Pile 2E. Color minimized for clarity.

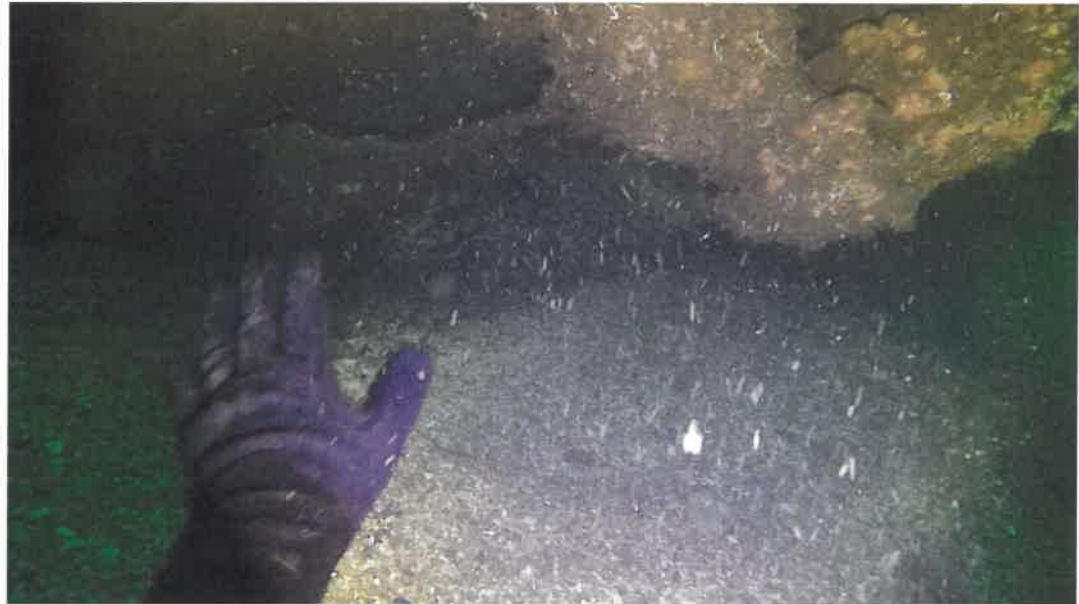
Exposed non-coated steel casing at groundline 2'(W) x 6"(H) below concrete overpour.

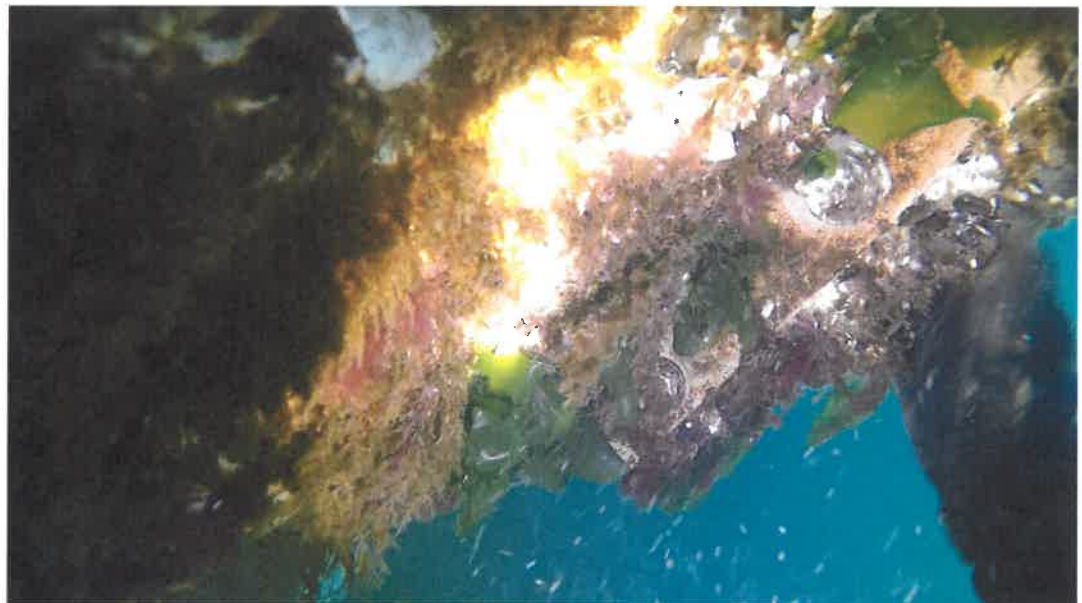
Pier 6 supercolumn fiberglass shroud lip has loose bolts. All bolts from water surface to the bottom of the shroud can be finger spun (Photos UW-5 and UW-6).

Pier 6 supercolumn fiberglass shroud lip has loose bolts underwater. All bolts from water surface to the bottom of the shroud can be finger spun.

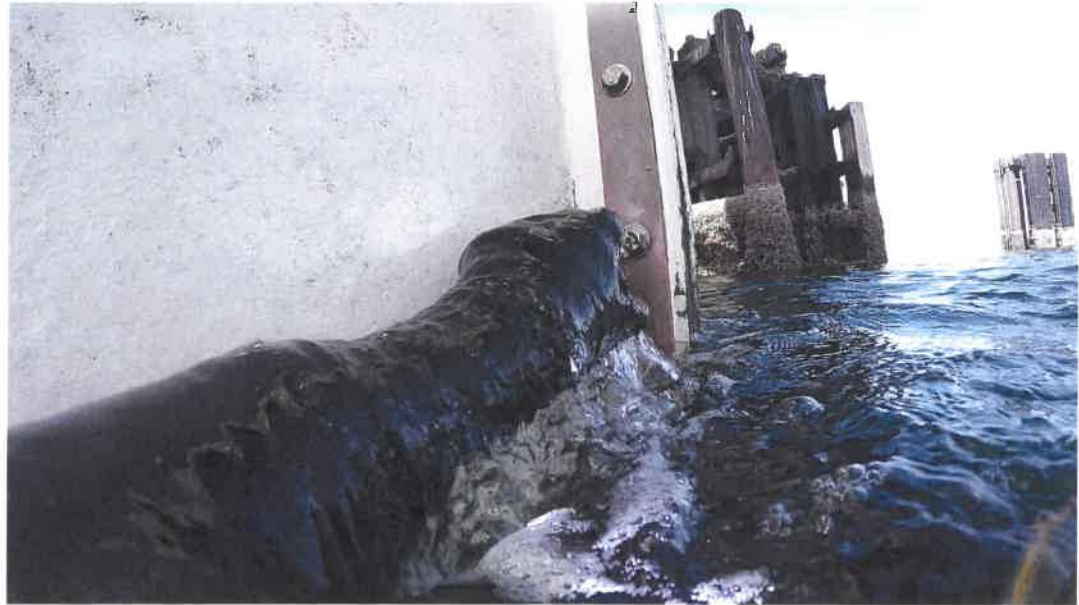
Pier 6 supercolumn fiberglass shroud lip has a loose bolt just above waterline.

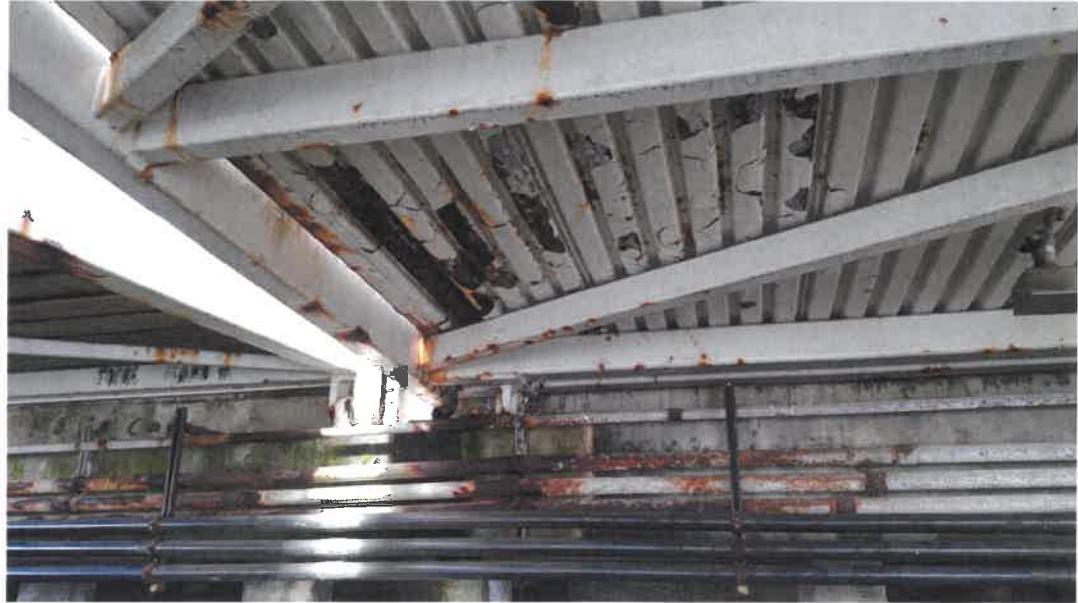
Soffit in Span 1 near right bearing has paint failure with rust blooms (element 8204 Photo #49).

WSF structure on right. Right truss member L0-L2 bottom chord with rust blooms.

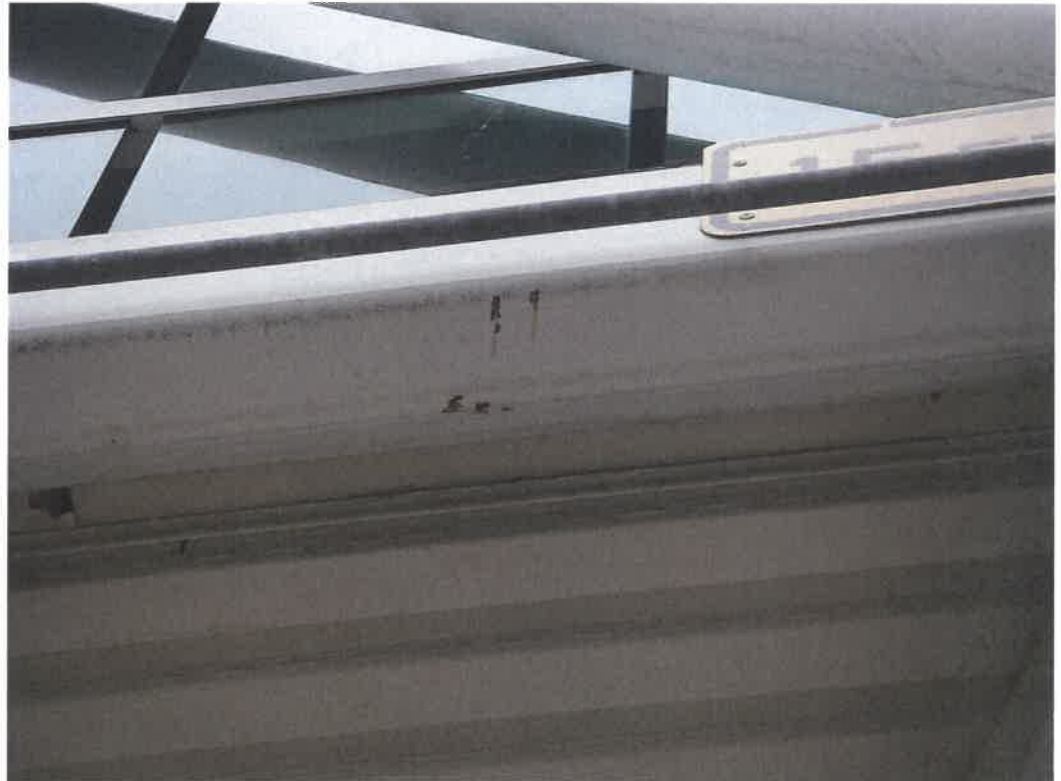
SI-36

Span 4 of the overhead walkway has bottom chord scrapes on both trusses, left truss shown.

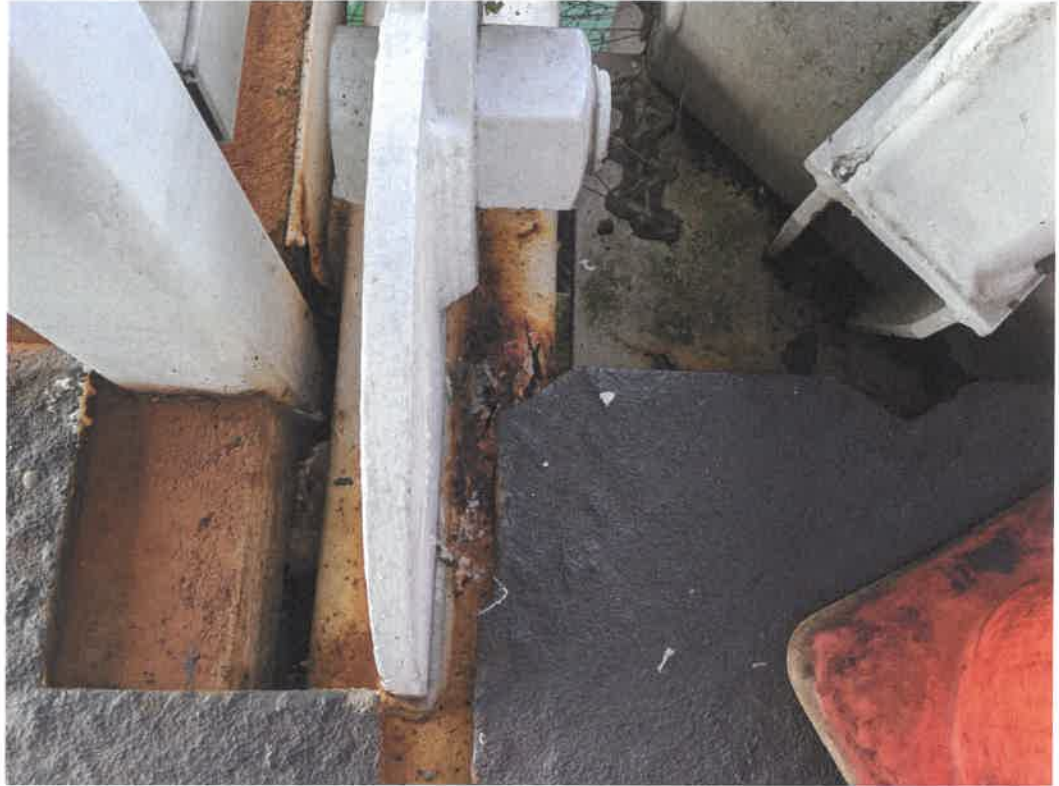
Span 5 truss left bottom chord at Pier 6 has surface and laminar rust on the top side.

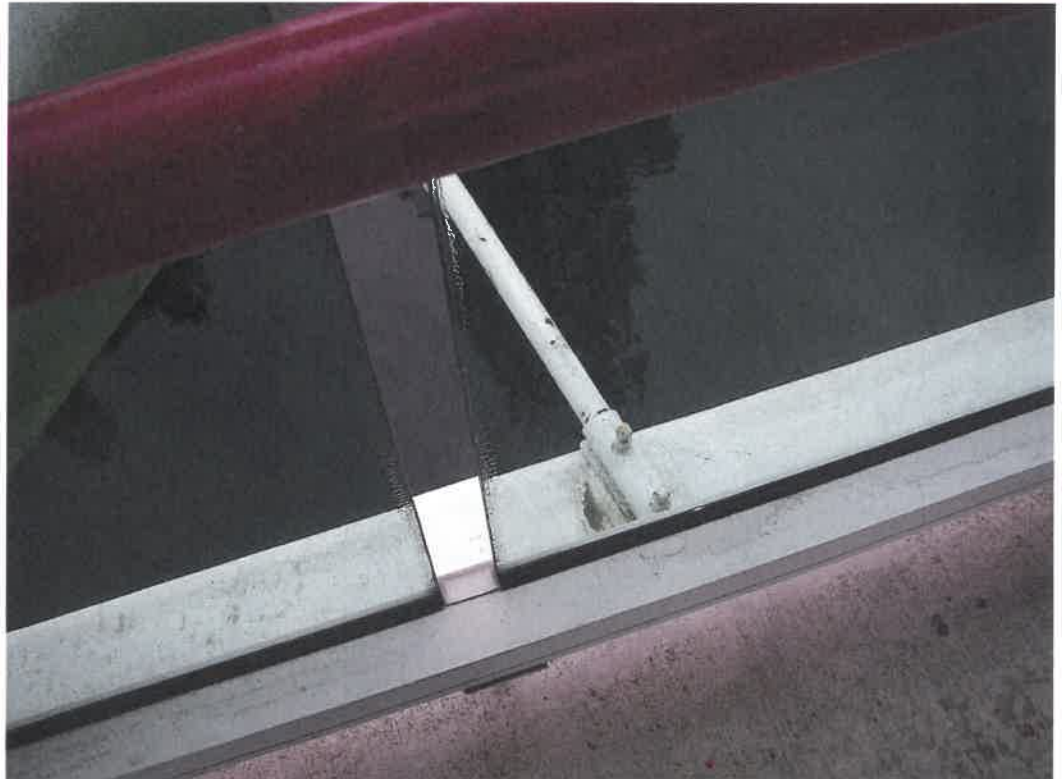
SI-39

Transfer Span 5 has mirrors welded to both right and left trusses bottom chord member L8-L10. Right truss shown.

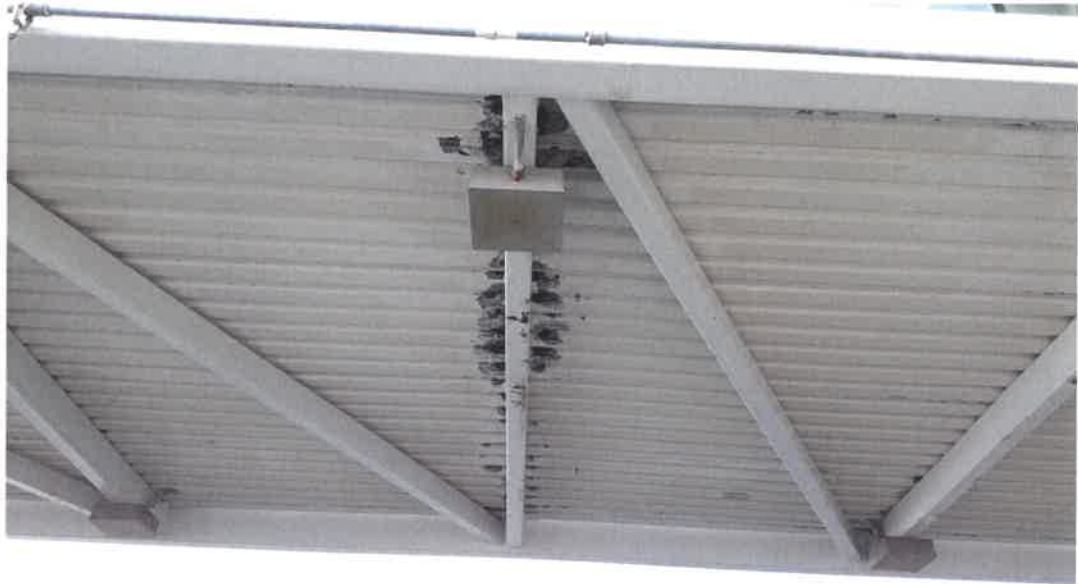
Soffit near FB4 in Span 3 has paint failure and rust blooms (Photo #46).

Soffit near FB4 in Span 3 has paint
failure and rust blooms.

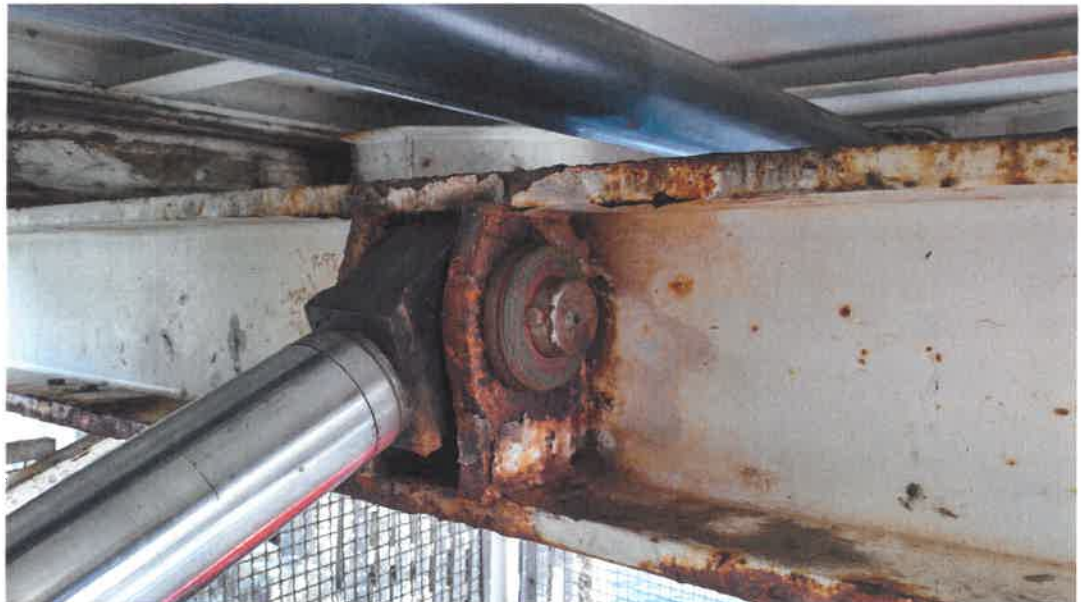
SI-31

Main lift arms and hydraulic rams are in good working order as are the pivot rams and all fittings. There is a 2" x 1/8" deep gouge in seaside pin plate at the top of the Slip 1 raising/lowering ram (Photo #31). Paint is failing in this area however a spot painting contract was ongoing during 2017 inspection. Update photo in 2021 inspection.

2 "X1/8" deep gouge in seaside pin plate
at the top of the slip 1 raising/lowering
ram. Looking shoreward.

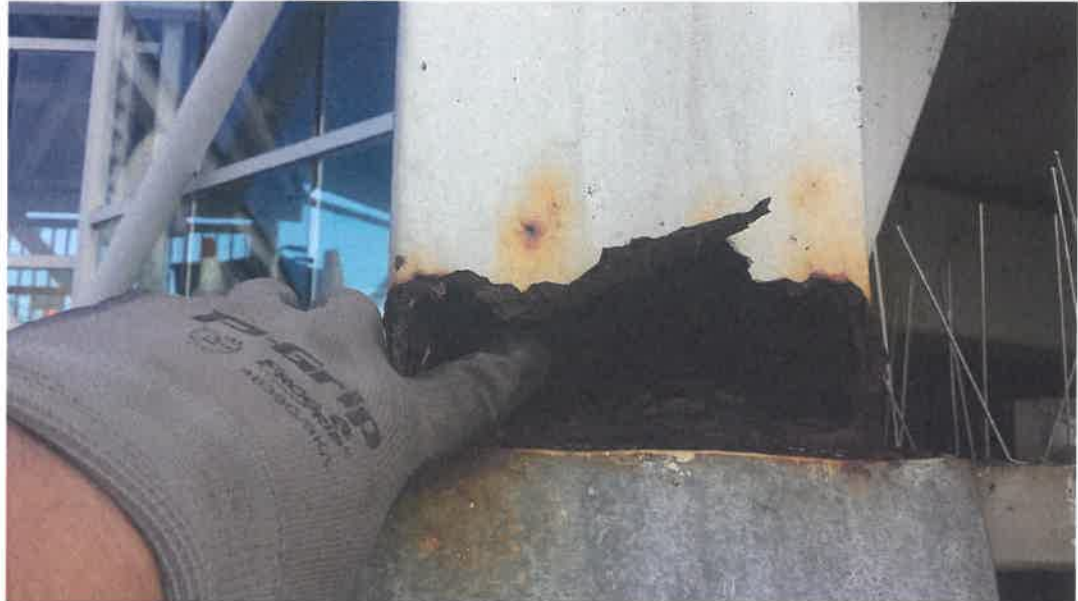
Slip 1 and Slip 2 gangplank, end of support beams are rusting through (Photos #44 & #45). These are thin cover plates at the end of the structural tubing, the rust is now propagating into the structural tubing. REPAIR #7.

Slip 2 gangplank, right/shore side, support beam end cover plate is rusting through.

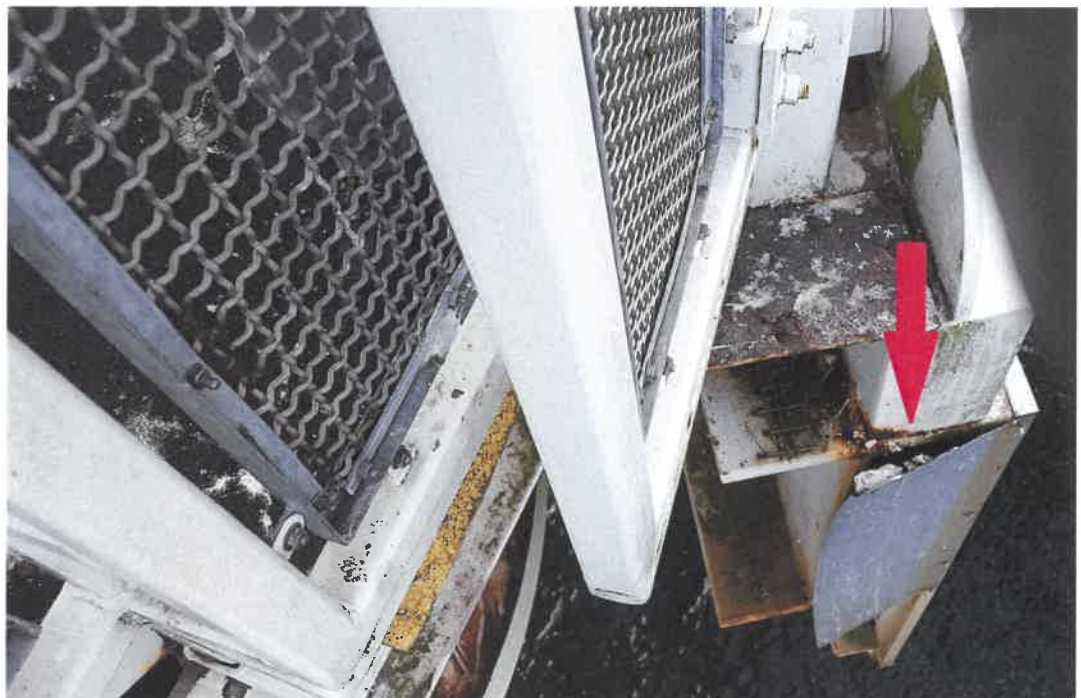
SI-45

Slip 1 gangplank, left/shore side, support beam end cover plate is rusting through.

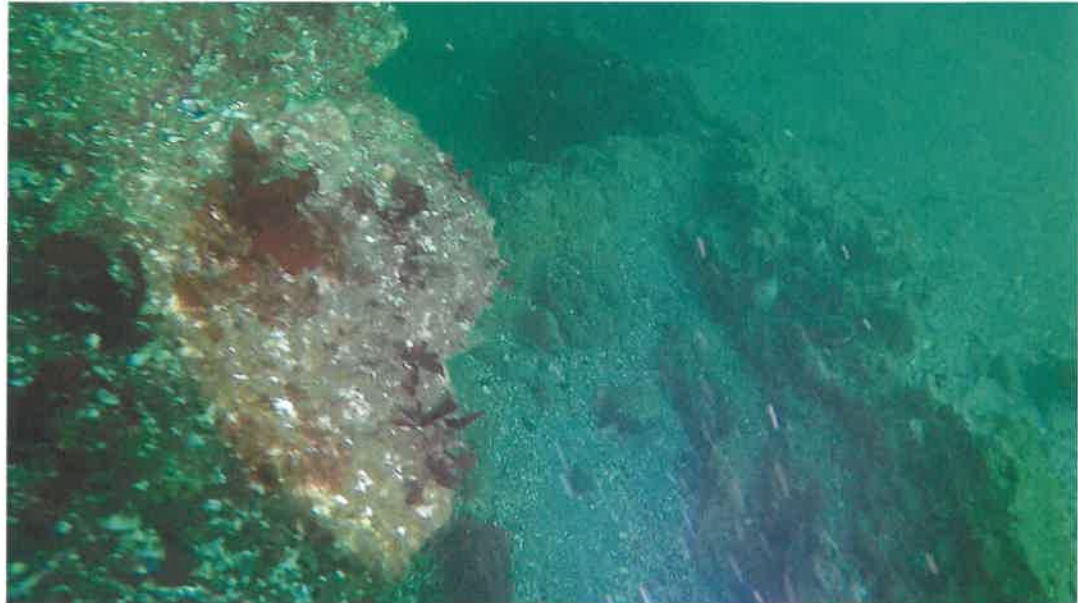
Pier 6 supercolumn has erodible clay on the right side to offshore (Photo UW-7). Transient sand surrounds the rest of the overpour below it. The top of the overpour is the same as the original 1993 mudline per the supercolumn as-builts. The surrounding material has degraded vertically to 11-ft. on the left side of the column (Photo UW-3). As-builts show the supercolumn shaft has 50-ft of remaining embedment. See dimensions of exposed overpour in Element 8129.

Pier 6 supercolumn has erodible clay on the right side to offshore. Note the overpour on the left half of photo which is 4-ft. off the ground.

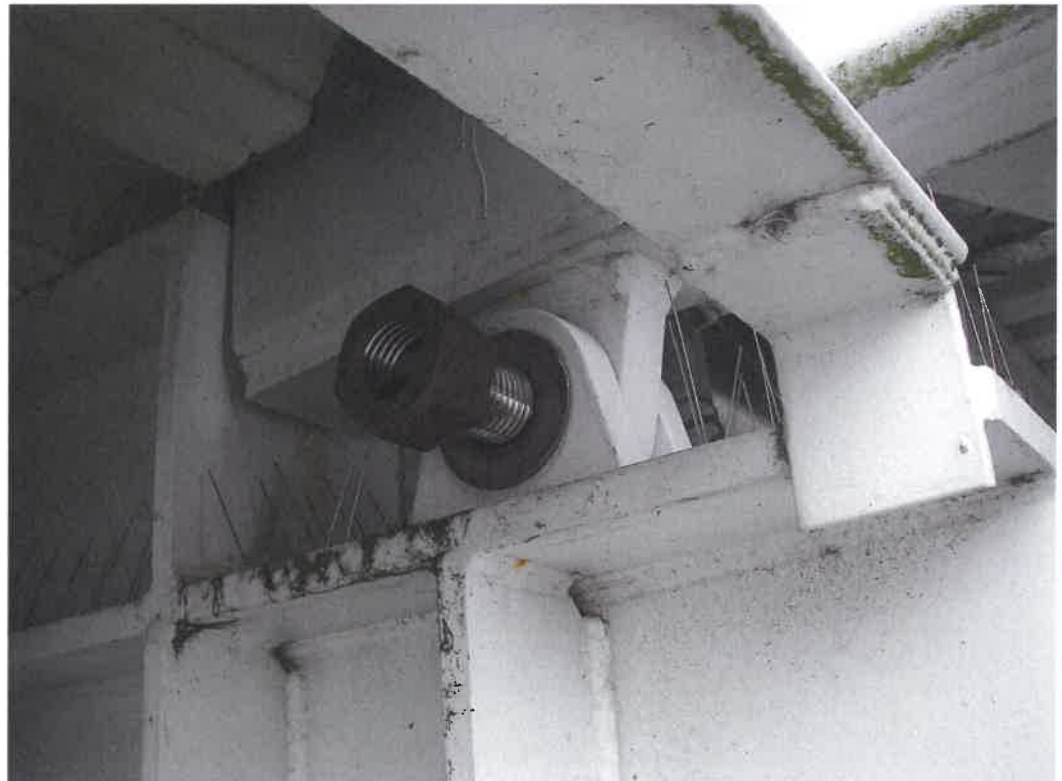
SI-40

Span 3 hinge connection at Pier 3, the pivot bolt has a loose nut (Photo #40). REPAIR #6.

Span 3 hinge connection at Pier 3 has a loose nut. Inspector hand loosened and hand tightened. Genie lifted needed to access.

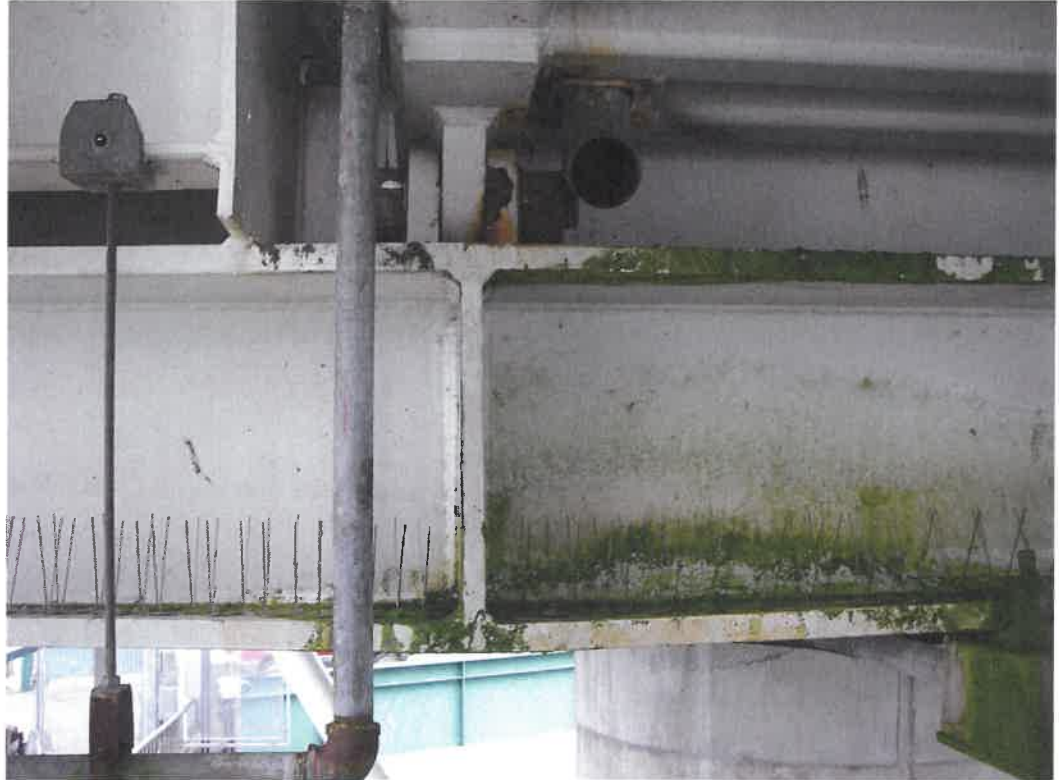
Span 4 bearing at Pier 5 has 1/8" thick laminar rust (Photo #42).

Span 4 bearing at Pier 5 has 1/8" thick laminar rust.

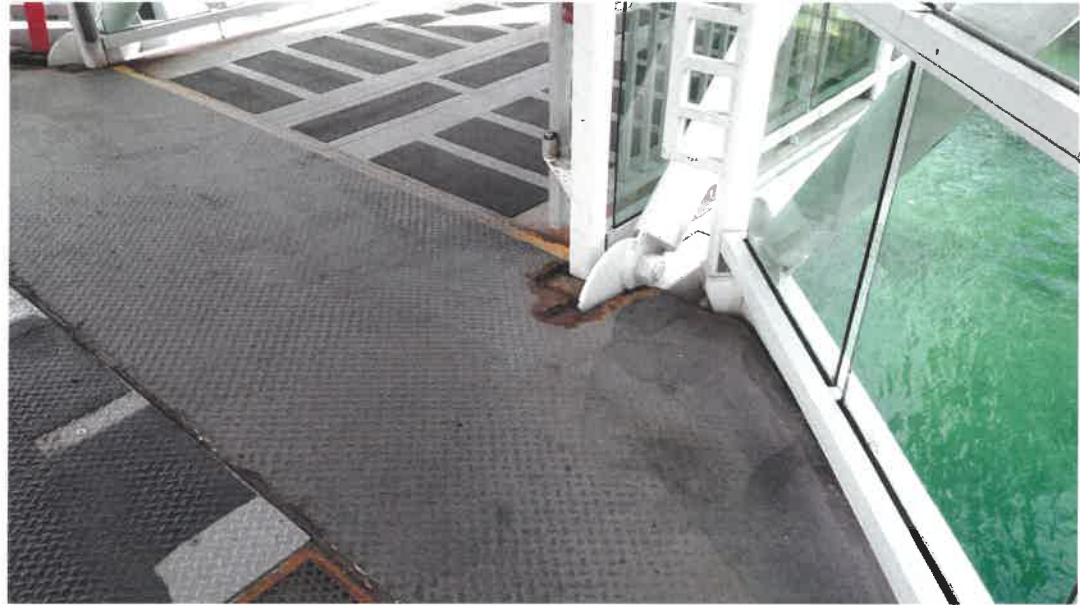
Truss end bottom chord sliding plate welds are undercut, rough, and rusty. There is surface rust around the plate edges at the truss (Photo #50).

Truss end bottom chord sliding plate welds are undercut, rough, and rusty. Left truss chord shown, right side similar.

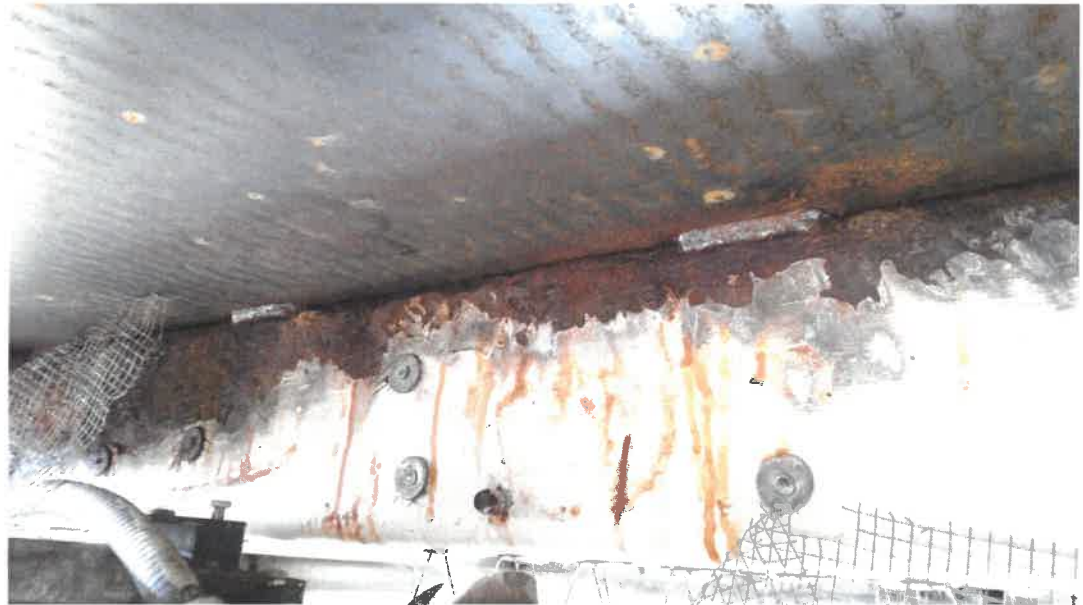
SI-52

Structural underside members have rust blooms with up to 10% section loss (Photo #52). (CS3) Much of the underside was painted in 2017, however rust is bleeding through again. Update photos next inspection.

Structural underside members have rust blooms with up to 10% section loss. Right gangplank shoreside member (worst case) shown.

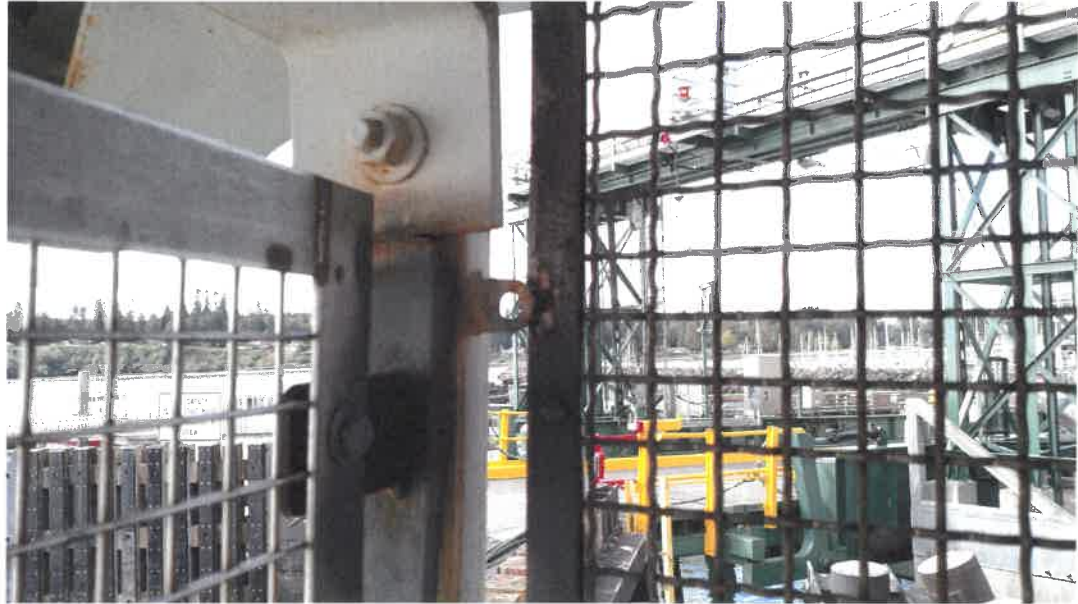
Right most shoreside fall protection grate panel in inspection cab under right gangplank is missing a bolt (Photo #51). REPAIR #8.

Right most shoreside fall protection grate panel in inspection cab under right gangplank is missing a bolt.

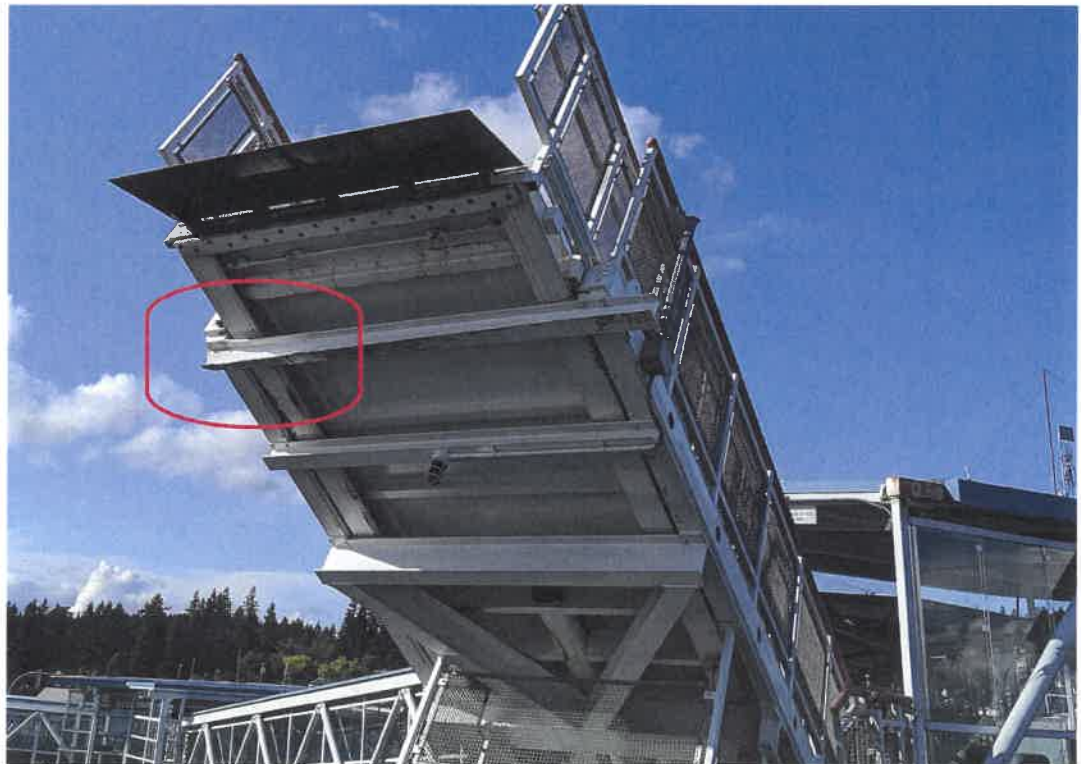
SI-53

Span 2 apron has a deformed underside support member at the offshore end (Photo #53). REPAIR #9.

Slip 2 gangplank apron has a deformed support beam from contact with the ship.
